The Earthquake of May 26, 1994, Al Hoceima, Morocco; Intensity distribution and macroseismic epicenter

Y. HAHOU^{1,2}, N. JABOUR², D. OUKEMENI¹, M. EL WARTITI¹, C. NAKHCHA¹

¹: Department of Geology, University Mohammed V, Faculty of Sciences Rabat, Morocco.

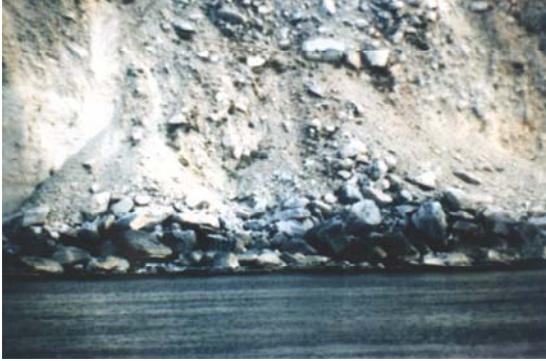
Fig. 2a- Soil falls in the coast cliffs of the Mediterranean Sea west of Al-Hoceima city.

The only primary effect of the event was the high ground acceleration level felt over a large epicentral area. No surface rupture was encountered or reported consistent with what is expected from this kind of earthquakes. Secondary effects included induced landslides; rock falls; soil falls occurred on many of the steep slopes; fissures and cracks in the ground and significant changes in water systems in the epicentral region and the surrounding regions (Fig. 2a and b).

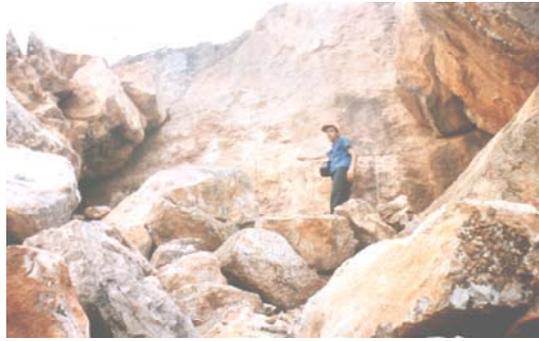
Fig. 2b – Rock falls in the cliffs of the Carabonita beach.

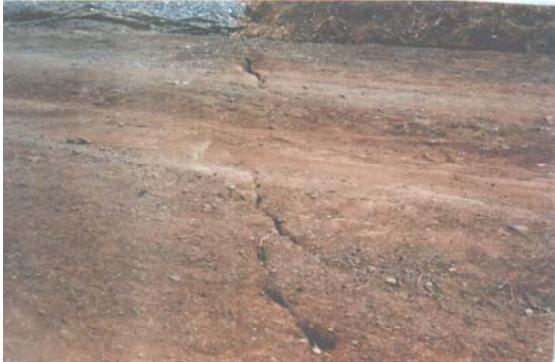
Fig. 3 – Fissures affecting ground in Tanda Ifran.

In the epicentral and the surrounding regions there were a series of ground cracks and fissures with several centimeters of width and about one hundred meters length, which are often very discontinuous (Fig. 3).

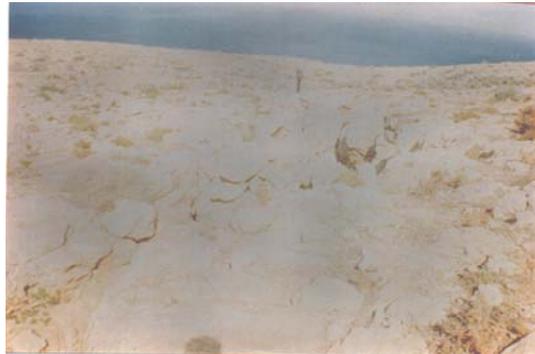
Fig. 4 – Fissures observed in Carabonita terrain..

In some cases, we observed change of underground waters' level. The level of underground waters changed over the whole zone affected by the earthquake, resulting in changes of the flow of existing spring and the level of water in wells as in Imernissene. Fissures appearing in the Kimmat Boussekkoûr, Kimmat Imassinene and Tafensa were the most interesting phenomenon of the earthquake of May 26, 1994. As a consequence of the main shock, some effects were observed at the surface, such as fissures; cracks at Idsouliyene, with a N40 to N50 trend, and land slides; soil falls and rock fall along the coastal cliffs west of Al Hoceima city. The cracks in the soil were observed over a large zone, especially on the Mediterranean coast in the western part of Al Hoceima. There were even landslides which caused the opening of ditches and great indentations. Such were observed especially in the Tafensa, Tanda Ifran and Carabonita beach (Fig. 4), as well as in many neighboring villages.

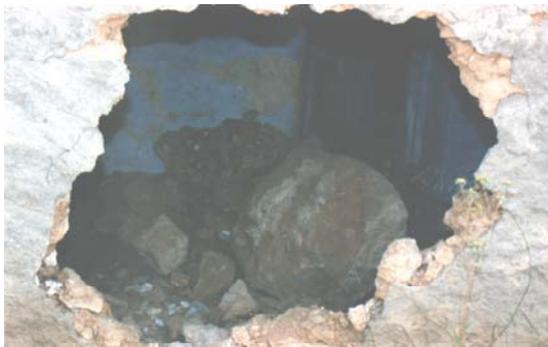
Fig. 5 – Wall destruction caused by rock fall in Douar Tafensa..

In the whole region of the epicentral zone many rocks fell from the mountainous terrain, and in many cases added to the extent of the damage suffered by the buildings especially in Douar Tafensa (Fig. 5 and 6).

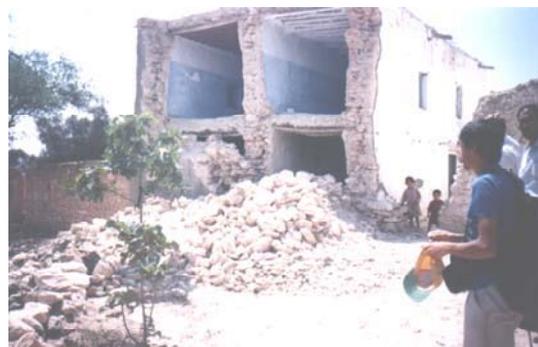
Fig. 6 – Adobe construction strongly affected by earthquake in Douar Tafensa.

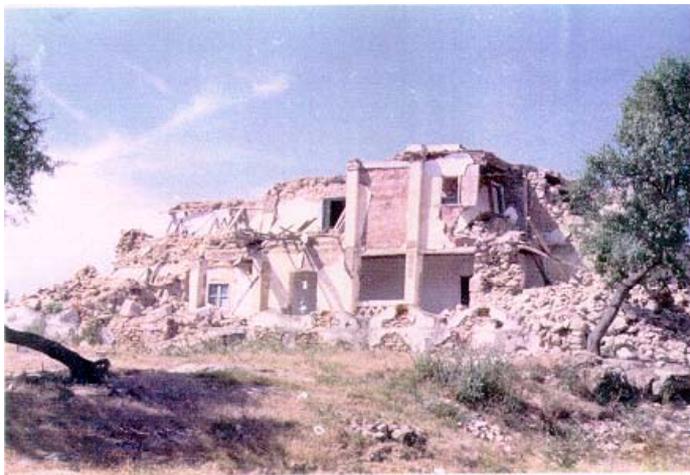
This earthquake caused widespread damage and was felt strongly throughout the northern of Morocco and south of Spain. Building construction was of very different types ranging from adobe and loose masonry of very poor quality to well constructed and good quality buildings. Adobes constructions suffered large cracks in walls in many cases (50-70%), partial destruction of walls in few cases and also total collapse

Fig. 7 – Total destruction of house in Izmourene.

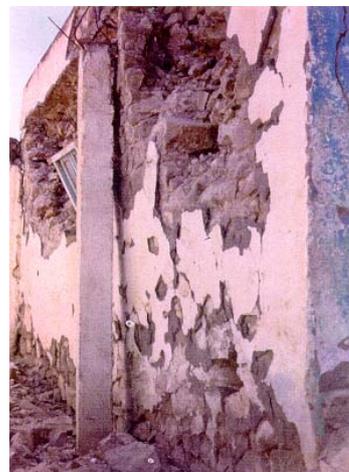
in many cases (Fig. 7). In Rwadi, Beni Abdella; Ait Kamra, Izmouerne; Immezouren and Beni Bouaiych, there were small cracks in several walls in many cases and heavy damage in a few ones. The constructions by bricks suffered large cracks; few wall displacement (Fig. 8) and many cases of cracks with multiple directions in Rwadi; Izmourene; Immzeroune and Beni Abdellah and beni Bouaiych. In general, the older constructions in Al Hoceima city suffered small cracks observed in many cases, but few ones suffered heavy damage. But in the buildings little non-structural damage was noticed in few cases.

Fig. 8 – Few displacement of the wall in Douar Rwadi.
